2015 Report Card on Beaches

Introduction to the Report Card on Beaches

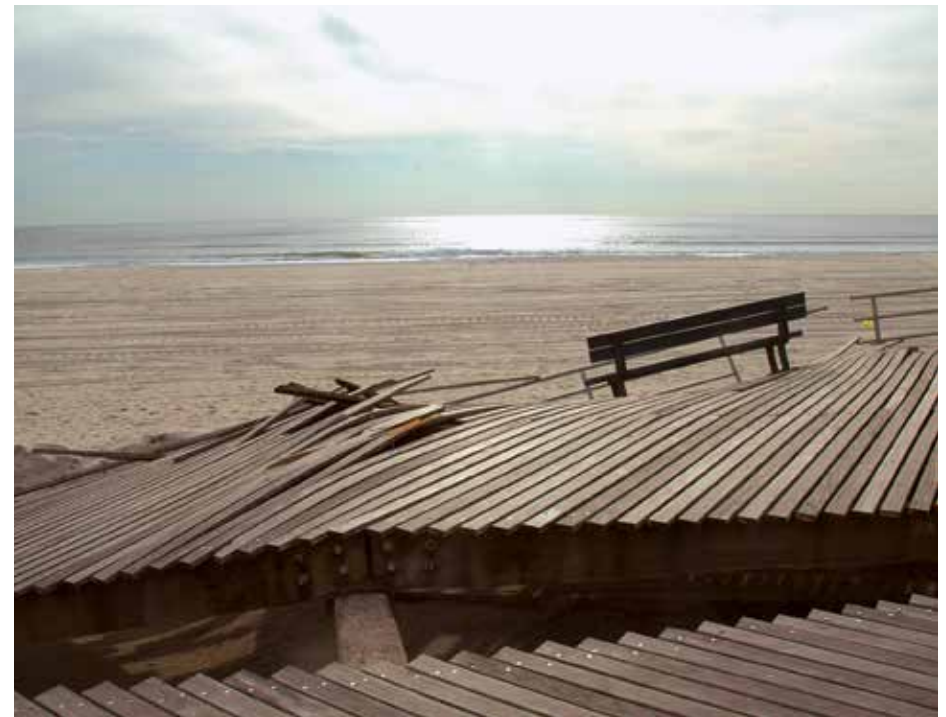
A damaged section of boardwalk at Rockaway Beach, Queens.

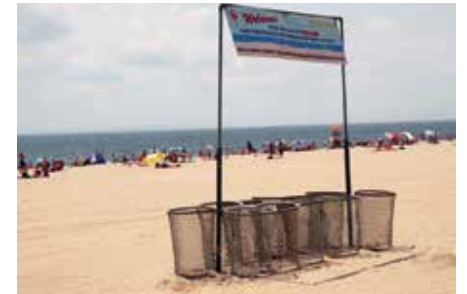
The well-maintained shoreline at Coney Island/Brighton Beach

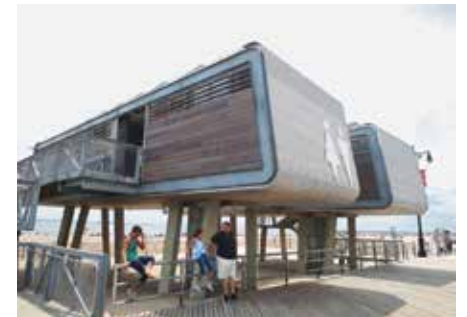
New, raised facilities are safe from future storm events

Coney Island/Brighton Beach suffered moderate damage from the Hurricane Sandy storm surge in October 2012. Facility electrical and infrastructure systems were the worst affected, and although the boardwalk stayed mostly intact, between two and five feet of sand was displaced from the beach onto nearby streets and sidewalks. By all accounts, the hurricane provided an opportunity to replace or renovate aging and deteriorating structures, and by summer 2014, all but one damaged building had been replaced, and sand replenishment had rejuvenated the beach. Coney Island/Brighton Beach's hodgepodge of facility styles now includes raised comfort stations and lifeguard rooms, a new design that is sensitive to rising seawaters and safe in the face of future storms.

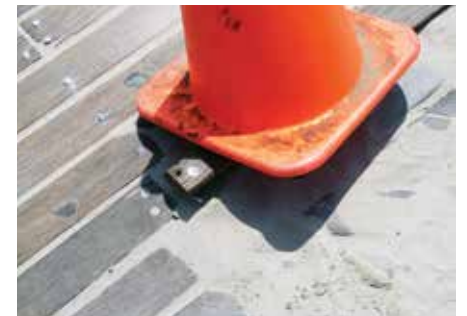
Pathway maintenance at Coney Island/Brighton Beach remains a challenge: pathways fell from a score of 99 in 2011 to a score of 78 in 2015. A third of surveyed areas on the Coney Island boardwalk suffered from trip hazards in the form of missing, raised or sunken sections. Additionally, a third of areas surveyed were affected by natural debris, including large sections of drifting sand.

A broken boardwalk plank and sand create a trip hazard on a pathway

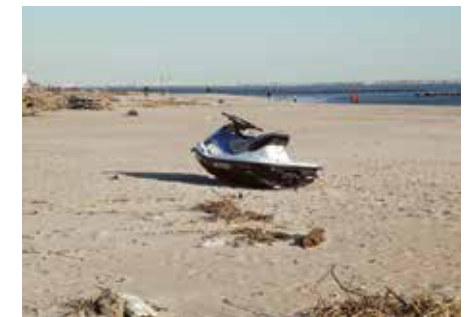
Debris from Hurricane Sandy covers Coney Island/Brighton Beach in 2012

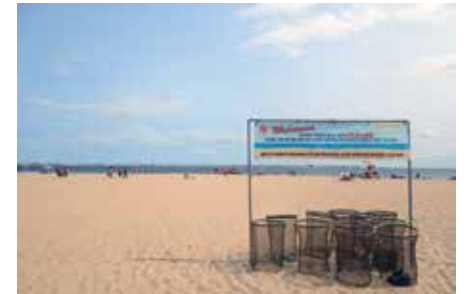
Trash is contained and emptied frequently at Manhattan Beach's well-maintained shoreline

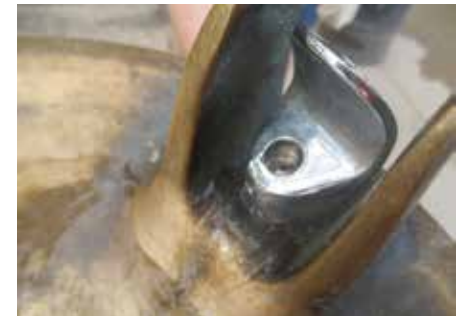
For the fourth *Report Card* in a row, Drinking Fountains scored lowest at Manhattan Beach, receiving a 56. An alarming 44% of Manhattan Beach's drinking fountains failed, due to a lack of pressure, clogged basins, or persistent leaks. Although this is poor performance, Manhattan Beach drinking fountains improved from a 2011 score of 38, and matched a 2009 score of 56. However, this consistent lack of satisfactory improvement indicates a need for dedicated plumbing attention to Manhattan Beach, and beaches across the city.

It is not possible to drink at this water fountain due to low water pressure

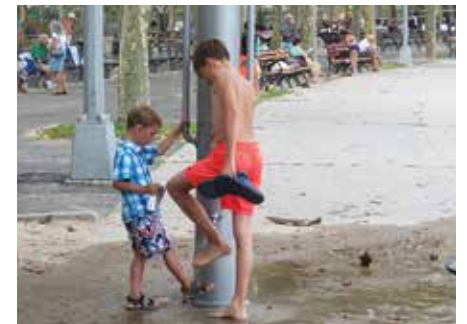
Dedicated spray showers allow beachgoers to rinse, but make the pathway harder to clean

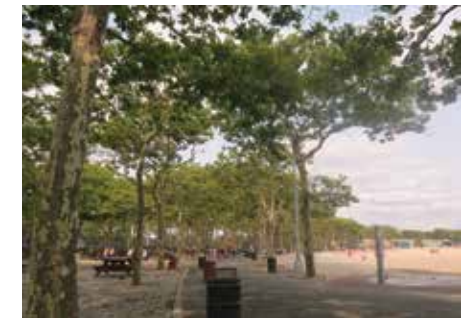
The shade trees and promenade at Manhattan Beach largely survived Hurricane Sandy

Manhattan Beach suffered moderate damage from Hurricane Sandy: reportedly, the damage was more significant than at neighboring Coney Island/Brighton Beach. Beach facilities were flooded, causing electrical and infrastructure failure. The beach's sand washed into the beach parking lot and neighboring streets. However, this presented an opportunity to renovate aging structures, and most work, including sand replenishment, was complete at Manhattan Beach by summer 2014.

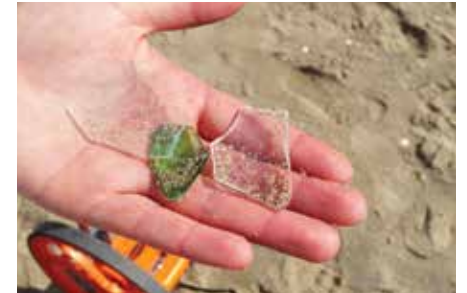
is still well-maintained: trash was contained to trash bins, entrances to the beach were well-maintained and safe, and lifeguards were appropriately provided and signposted. However, 75% of the surveyed transects were affected by broken glass, a significant hazard to beachgoers.

Sharp glass is a frequent hazard on Orchard Beach's otherwise well-maintained shoreline

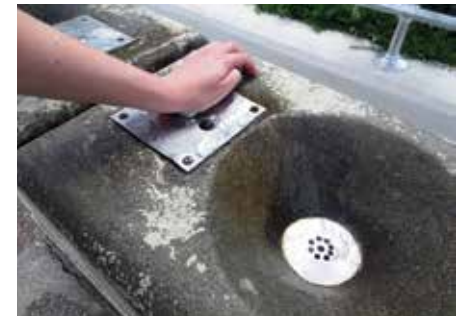
Drinking Fountains received a failing grade of 36, falling 48 points from a high in 2011 of 84. As in previous years, a large number of drinking fountains were found to be unacceptable. 38% of fountains did not have sufficient pressure to allow use. The immediate areas of 14% of the fountains were affected by excessive sand, mud or standing water, and a further 14% had standing water or debris in the fountain basin. Additionally, almost half of the fountains were found to have visible structural damage, like cracks and leaks. It is clear that Orchard Beach's drinking fountains are no longer serving the beachgoing population well.

Pressure at this drinking fountain is too low to allow use

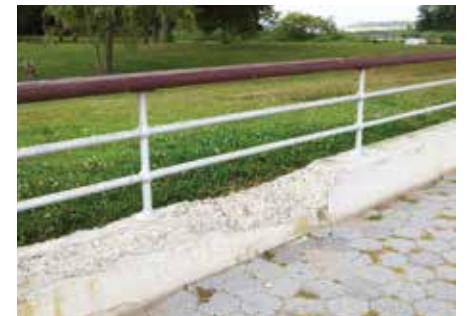
Deferred maintenance and storm damage have contributed to the deterioration of the Orchard Beach Ship's Rail

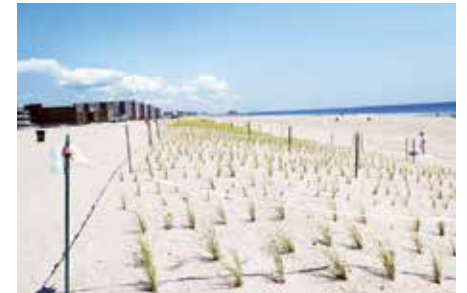
Beach grass has been planted on Rockaway's dunes, and is protected from beachgoers

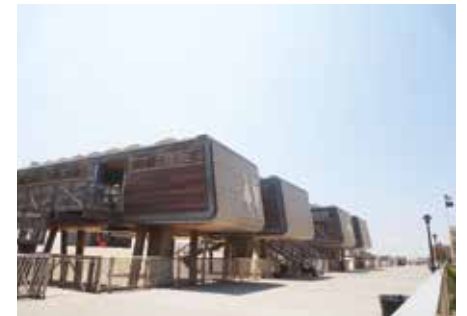
Rockaway's reconstructed boardwalk and facilities are new since the 2011 Report Card, were installed as part of the Hurricane Sandy recovery

SUCSESSES
The boardwalk at Rockaway Beach was 5.5 miles long before the storm. Now present in sections, the boardwalk that exists is in excellent condition, and received a score of 93 for pathways. This is a decline from 2011, when Rockaway Beach scored 100 for pathways. Although much of the boardwalk is in excellent condition, some sections were

found to have cracked concrete or boards in poor repair on wooden sections. The missing boardwalk sections are scheduled to be rebuilt in the next few years.

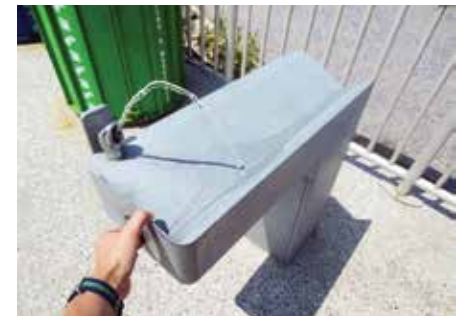
Drinking Fountains improved from a score of 71 in 2011 to an 86 in 2015, largely helped by the installation of a new drainless drinking fountain design in reconstructed areas. This metal model directs water into a trough that continues down the fountain column, directing waste water into a floor-level drain. A small number of fountains failed due to visible leaks. Otherwise, drinking fountains at Rockaway Beach were largely clean, working, and well-maintained.

A drainless drinking fountain directs water and debris away from the user into a ground-level drain: it's usable even if the drain is clogged

NYC Parks should continue to install beach infrastructure such as drainless drinking fountains and stand-alone spray showers. Found along parts of Rockaway Beach, drainless drinking fountains steer excess water along the body of the fountain towards a drain in the boardwalk surface at the rear of the fountain. These fountain basins do not clog with sand or debris, making them easier to maintain and more pleasant to use. Stand-alone spray showers allow beachgoers to rinse off sand and saltwater. With dedicated plumbing and auto-timed fixtures, they provide a valuable service to beachgoers while saving water.

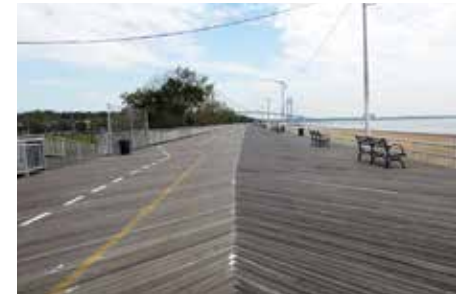
South Beach's boardwalk, with the Verrazano-Narrows Bridge in the background, is in very good condition

The pathways at South Beach received a 94, equaling the 2009 score, and almost reaching the perfect score achieved in 2011. Aside from one pathway section with boardwalk damage, the South Beach boardwalk was clear of trip hazards, weeds, dirty conditions, and glass.

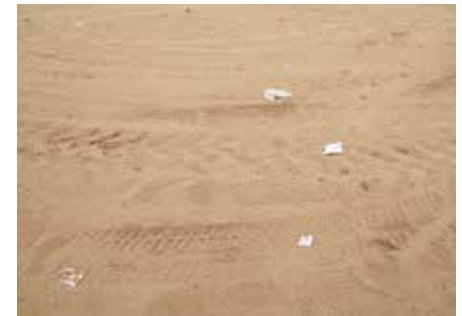
After improving 92 points in the last *Report Card*, South Beach's shorelines declined by 32 points in the 2015 results. Scoring 68, the surveyed shoreline sections were found to be uniformly affected by broken glass. 20% of the shoreline surveyed had an unacceptable amount of litter. Additionally, the beach has been physically transformed since Hurricane Sandy: manufactured sand dunes berm the beach, providing coastal protection, but also create a barrier to access. These dunes are not signposted, and they are at risk of collapse due to beachgoer traffic.

Sections of the shoreline were strewn with unacceptable amounts of litter

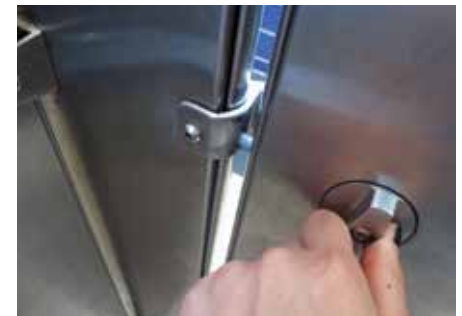
South Beach's bathrooms were plagued with plumbing issues and damaged features, resulting in a grade of 79: this is the lowest score this MSA has received over four *Report Cards*. 50% of the bathrooms had non-locking stall doors, and 75% had non-functioning sinks. 25% were found to have non-functioning toilets, and 50% lacked liquid soap. However, the bathrooms were clean, suggesting that lingering storm damage may be responsible for some of the non-functional features.

Many bathroom stall doors are damaged and do not lock

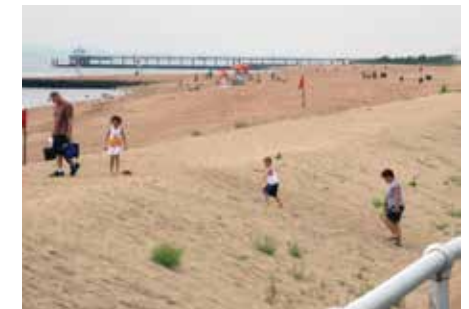
Protective dunes have no signage or clear access points, leaving the structures vulnerable to beachgoer traffic

In order to safeguard beachgoers and protect fragile beach features, such as sand dunes, NYC Parks must maintain a consistent signage practice to demarcate where activities and access are allowed. Some beaches have non-swimming areas: beachgoers must know where they are being safely observed in the water. New York City's swimming beaches have, since Hurricane Sandy, become ringed with sand dunes built to protect upland areas from future storm threats. These fragile dunes will fail if they are not appropriately signposted. NYC Parks should determine dune crossing points at beaches and mark them with beach mats, signage, and stakes, as is done at Rockaway Beach. This prevents beachgoers from climbing on the dunes, eroding the structures, and reducing the efficacy of this flood prevention infrastructure.

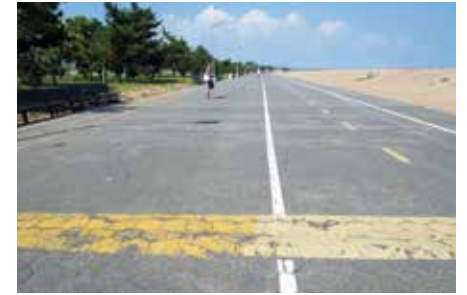
Midland Beach's pathways offer a near-pristine surface for walking and biking on the beach

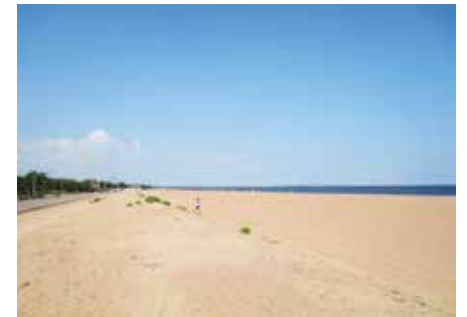
However, 80% of the sections surveyed had protective dunes that lack appropriate prohibitive safety signage.

Although the shore is well-maintained, the sand dune is unmarked and unprotected

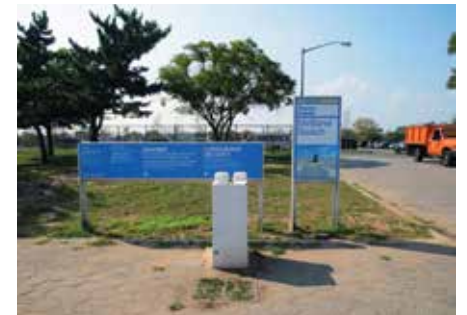
Drinking fountains declined 36 percentage points, receiving an alarming 45. Half of the drinking fountains failed inspection, often due to low pressure, lack of water, or persistent leaks. In addition, several fountains were had significant structural problems, such as broken spigots, or structural cracks. The majority of Midland's drinking fountains are concrete structures, which crack easily in severe winter weather.

Midland Beach's concrete drinking fountains are in poor working condition

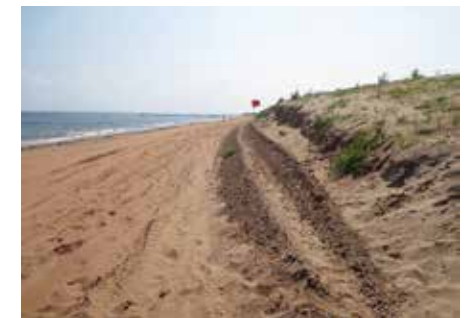
Like neighboring South Beach, Midland Beach was severely affected by Hurricane Sandy. The force of the storm carried away a tremendous amount of sand, flooded beach operations and maintenance facilities, and inundated comfort stations. Although initial debris removal and the provision of temporary facilities allowed Midland Beach to open for the 2013 summer season, it still has long-term recovery needs. Midland Beach now sports a temporary dune that acts as a berm, and has an intended lifespan of 5-to-10 years, but is currently not safeguarded from beachgoer activity. Additionally, the beach is served by a bevy of temporary comfort stations, which must be replaced by permanent facilities.

Hurricane Sandy carried away feet of sand at Midland Beach, and the erosion is still visible

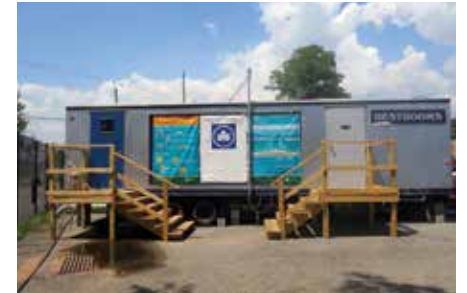
Cedar Grove Beach's temporary comfort stations were the highest scoring beach bathrooms

rooms scored highly—they were the highest-scoring bathrooms found in the 2015 *Report Card* and received a 92. With the exception of missing toilet paper and a bathroom with a non-functioning stall, Cedar Grove Beach's bathrooms were clean, well-maintained, and well-functioning.

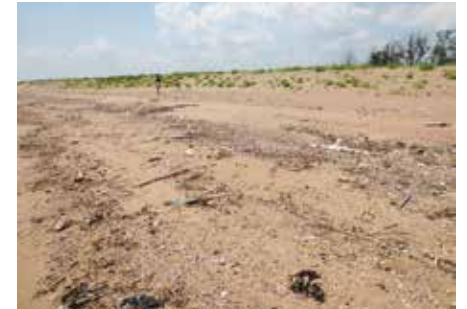
Not all of Cedar Grove Beach's shoreline is swimmable. The areas where swimming is permitted are well-signposted. However, the protective sand dunes along the beach did not have adequate signage in the areas where swimming is prohibited. Both sections of shore at Cedar Grove Beach that were surveyed were affected by broken glass, and litter was found to be a problem in one of the sections. The shoreline scored a 65, showing clear areas for improvement in the beach sections that are outside of the swimmable areas. Maintenance and cleanliness were found to be significantly better in areas near the swimmable shoreline sections.

Some of Cedar Grove's shoreline is poorly maintained, and sand dunes are left vulnerable to human activity

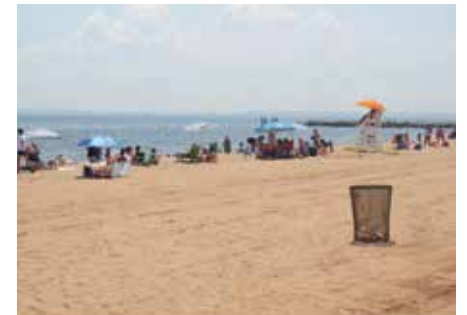
Lifeguard protection and maintenance is excellent in the designated swimming areas

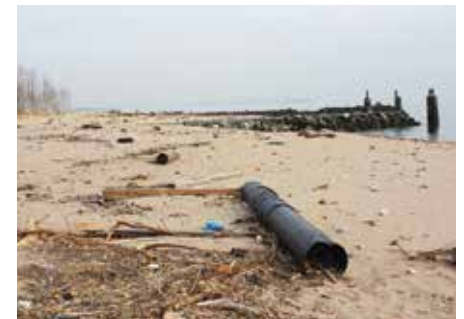
Cedar Grove Beach was covered with debris after Hurricane Sandy in 2012

Hurricane Sandy pummeled Cedar Grove Beach, causing the newly-opened park facility to close until summer 2013. The site of a former vacation colony on Staten Island's South Shore, Cedar Grove Beach was characterized by the modest bungalows that are found north of the beach. Few bungalows survived the storm. Like other beaches in Staten Island, Cedar Grove Beach was affected by storm debris, loss of sand, and flooding of existing beach facilities. The beach was not opened for the 2013 summer season, and did not open until partway through the 2014 summer season, due to continuing storm recovery activity. Although new elevated facilities were constructed for Staten Island parks maintenance and operations employees, the majority of the facilities at Cedar Grove beach remain temporary.

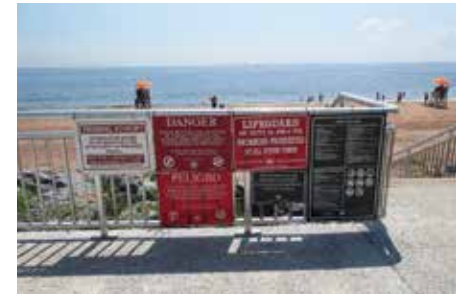
Appropriate safety and rules signage is present at one of the official entrances to the beach

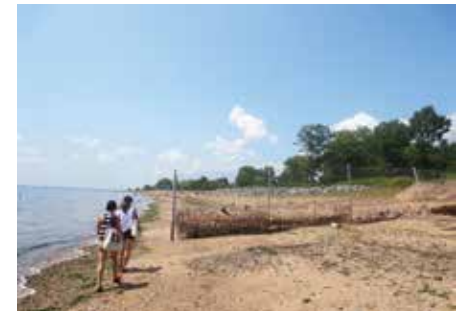
The fence that separates the eastern, non-maintained part of Wolfe's Pond Beach from the maintained central zone is passable at low tide and not well marked

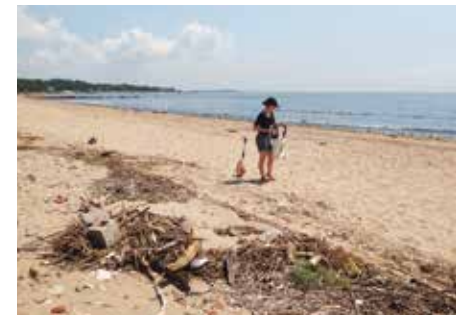
mirror the sections randomly selected in 2011, were strewn with excessive litter or large natural debris. While required signage was present at the three central entrances to the beach, none of the surveyed sections contained signage or notification indicating that no lifeguards were present or that swimming was prohibited. A small section at the center of the beach was groomed, maintained, and supervised by lifeguards. A fence separates this section from a non-maintained, non-swimming section of natural shoreline to the east. However, that barrier does not prevent beachgoer access during low tide, and does not indicate to beachgoers that the area to the east is non-maintained. In 2011, surveyors found signage on a stretch of fencing to the west of the maintained area that indicated a non-maintained zone, discouraging public access. This signage no longer exists as Wolfe's Pond Beach. Wolfe's Pond Beach is in dire need of sand replenishment, which would assist NYC Parks as the agency continues to care for this waterfront resource.

The shore was affected by excessive litter and natural debris

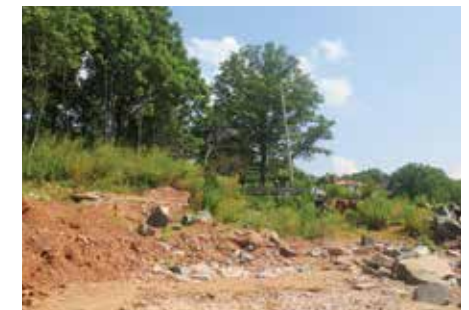
Like other Staten Island beaches, Wolfe's Pond Beach was dramatically affected by Hurricane Sandy. Although all beaches on Staten Island's South Shore lost sand, Wolfe's Pond Beach was decimated. It lost almost all of its sand, and the underlying clay has been exposed along parts of the shore. Initial debris removal occurred in the months following the storm, but flooding had severely damaged existing comfort stations. The beach remained closed until the summer of 2014, when new elevated comfort stations were installed. Despite having new facilities, Wolfe's Pond Beach is far from recovered. Most critically, the beach needs sand replenishment to restore the shoreline to a condition that serves the public and can be better maintained by NYC Parks.

Erosion at Wolfe's Pond Beach from Hurricane Sandy has stripped sand from the shore

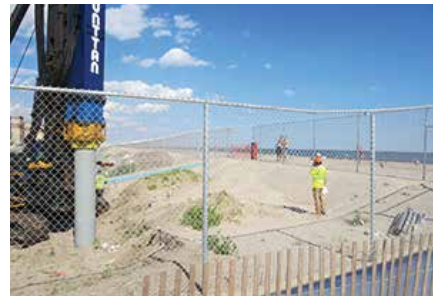
Construction at Rockaway Beach includes driving piles to support boardwalk reconstruction.

Although many of the facility and infrastructure repairs necessitated by Hurricane Sandy have been completed, there is more work to be done. Rockaway Beach, in particular, faces a multi-year phased reconstruction to restore the boardwalk, beaches and facilities.

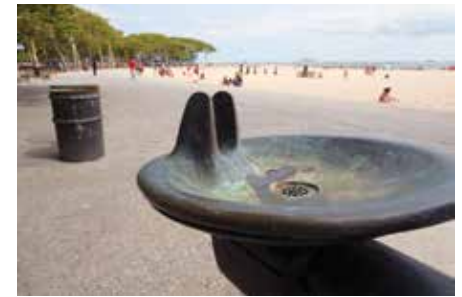
Drinking fountains across the city's beaches would benefit from frequent plumbing work

The summer beach season stretches NYC Parks' plumbers beyond capacity: drinking fountains, spray showers, comfort stations, and ornamental fountains at beaches require more plumbing attention than the city can provide. In addition, where wooden boardwalk exists, frequent carpentry maintenance is needed to keep the walking surface safe and in good repair. Creating specific contracts for beach plumbing and carpentry will reduce the load on NYC Parks staff, and will allow plumbing and carpentry attention to remain at normal levels in parks throughout the city that are non-beach properties.

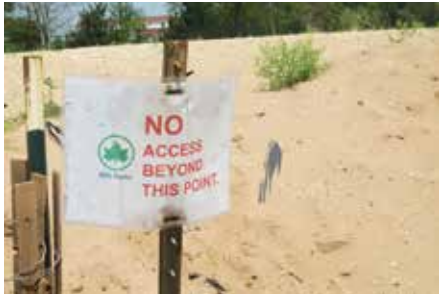
Dune access is prohibited at Cedar Grove Beach

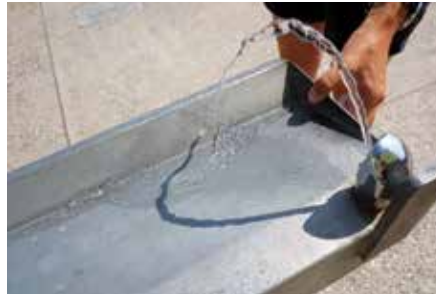
A drainless drinking fountain at Rockaway Beach

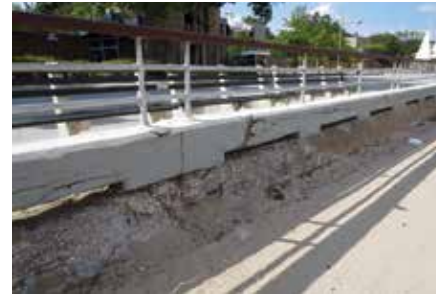
The promenade at Orchard Beach needs immediate capital attention

CREATE A CAPITAL PLAN FOR THE REDESIGN AND RESTORATION OF ORCHARD BEACH

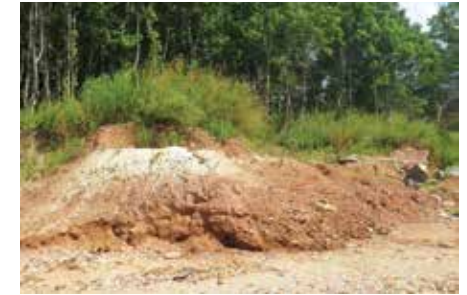
Erosion at Wolfe's Pond Beach makes maintenance difficult

REPLENISH THE SAND AT WOLFE'S POND BEACH AND OTHER STATEN ISLAND BEACHES
